Technical Note N= 1446

THE CEL 100K PROPELLANT ANCHOR - UTILIZATION FOR TANKER MOORINGS IN SOFT CORAL AT DIEGO GARCIA

D. G. True and R. J. Taylor

July 1976

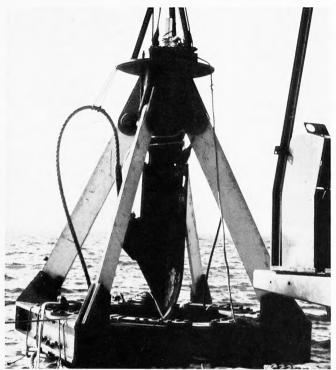
Figure 1. The CEL 100K Propellant Anchor System being deployed, loaded with a coral/ sand fluke and a retrievable piston.

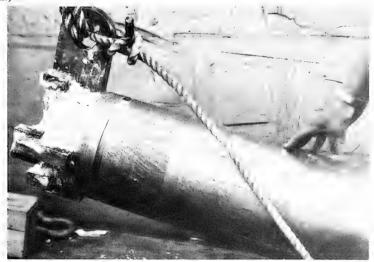
Figure 4. Retrievable piston after use.

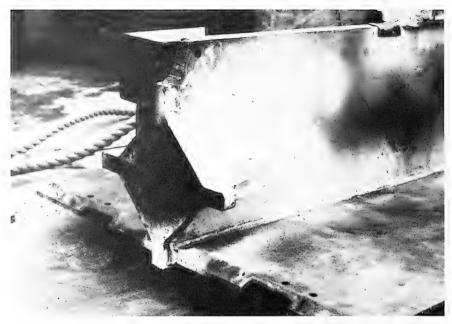
Figure 5. Rear of fluke, showing base plate and holes for shear pins.

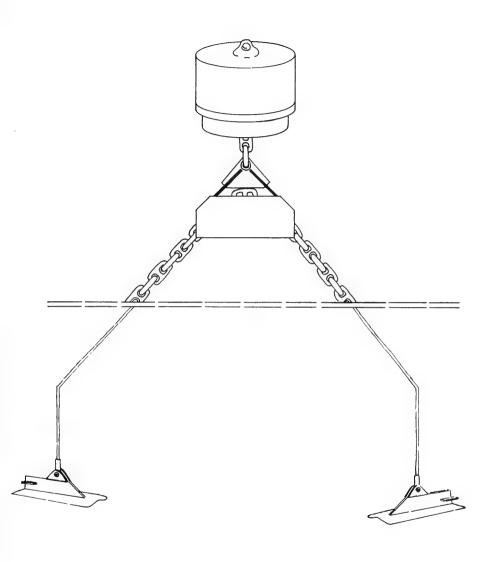
Figure 7. Mooring leg configuration at temporary site.

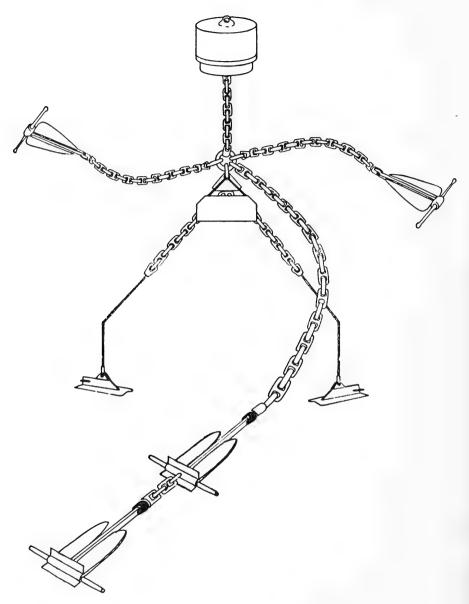
Figure 8. Typical mooring leg configuration at permanent site.
